## CATERPILLAR D6 LGP - CE

# INSPECTION REPORT

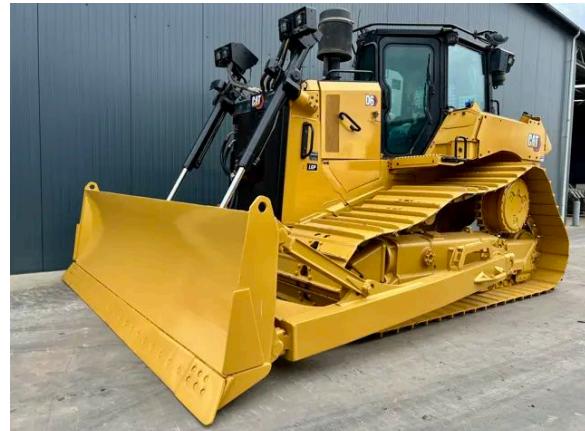
Caterpillar D6 LGP, Engine brand Caterpillar , C9.3, 187 kW, CE, Air conditioning, Erops cabin, Straight tilt blade, Width of the blade 4.02m, Differential steering, Ripper valve, Width of the pads 915mm, Draw bar, Backup camera, Beacon, New ripper available, ask for quotation, Hours certified by Caterpillar, In very good and very clean condition.

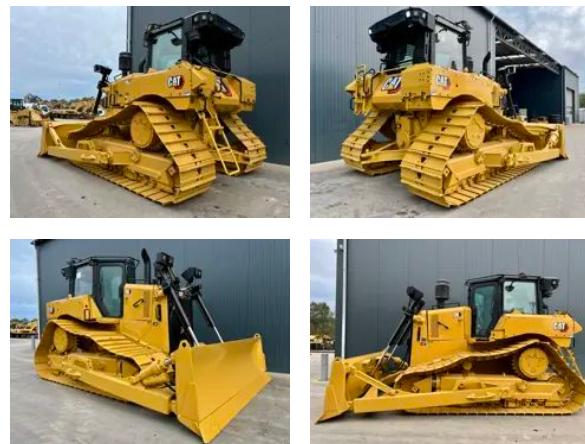
Year	2020
Hours	10086
Weight	24.000 kg
Serial number	CAT000D6VGZ900390
Reference	207520
