CATERPILLAR 140H

| Serial number | CAT0140HAAPM00827 |

INSPECTION REPORT

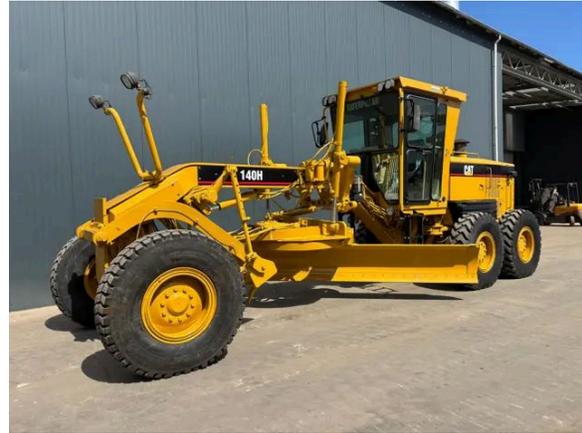
Caterpillar 140H, Engine and model Caterpillar 3176, 153 kW, Air conditioning, 14.00R24, Scarifier, 6x4, High profile erops cabin, Auto shift, Hydraulic tip control, Width of the center blade 4.27, Blade lift accumulators, Central lubrication, Backup camera, Differential unlock, Hours certified by Caterpillar, Beacon, New ripper and front blade available, ask for quotation, In very good and very clean condition.
